The vacuum phenomenon in the ankle joint: Air bubbles on CT

The Foot and Ankle Online Journal 11 (2): 2

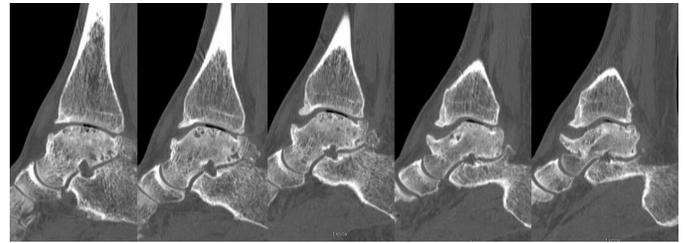
Figure 1 50 year-old male, sagittal CT scan of the ankle. Note the gas formation in the joint as well as presence within the subchondral bone region. Associated talar dome arthritic changes. Images are left to right, lateral to medial.

A CT scan of the ankle exhibited degenerative joint disease to the talotibial joint along with a large anterior osteophyte of the distal tibia and talar neck at the ankle joint level. The CT scan also exhibited intra-articular gas centrally within the joint (Figures 1-3). Upon discussion with the reading radiologist it was declared that the gas was related to the VP. Further discussion with multiple facility radiologists where the study was performed revealed that the gas is due to nitrous oxide from surrounding synovial tissues, but can also be due to positioning of the ankle joint at the time of the study. From their experience, most VPs noted by these radiologists occur primarily in the lumbar spine and shoulders. None of them have seen such a finding in the ankle until this particular case.

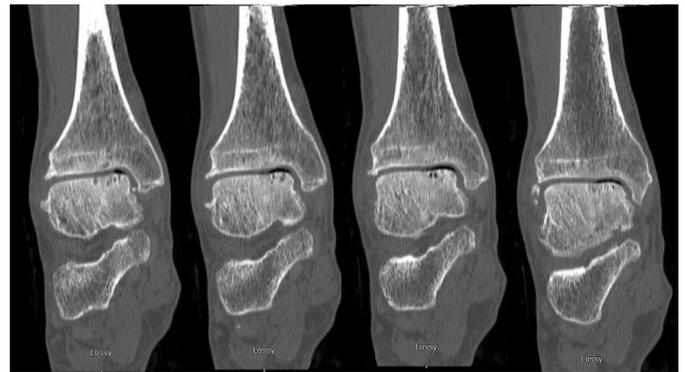
Figure 2 50 year-old male, coronal CT scan of the ankle. Note the gas formation centered around, and within the cystic changes to the medial talar dome. Images are left to right, anterior to posterior.

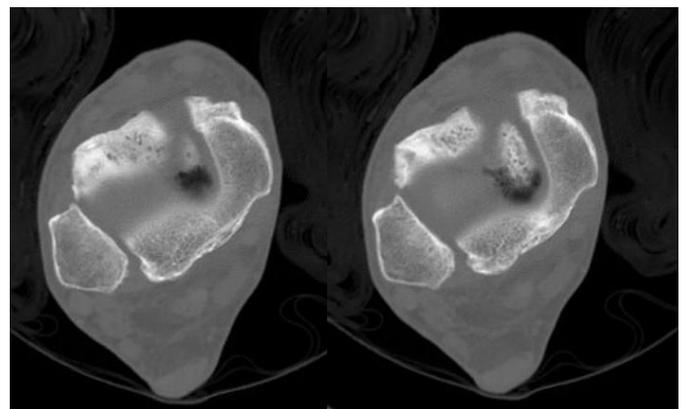
Figure 3 50-year-old male, axial CT scan of the ankle. Note the gas formation is positioned with the lower-lying cartilage defect space. Images are left to right, superior to inferior slices.
